# **INFLUENCE OF THE CHELUNGPU FAULT ON A HIGHWAY BRIDGE FOUNDATIONS AND COUNTERMEASURE**

**Tung-Lih Yen**  
***Moh and Associates, Inc.***

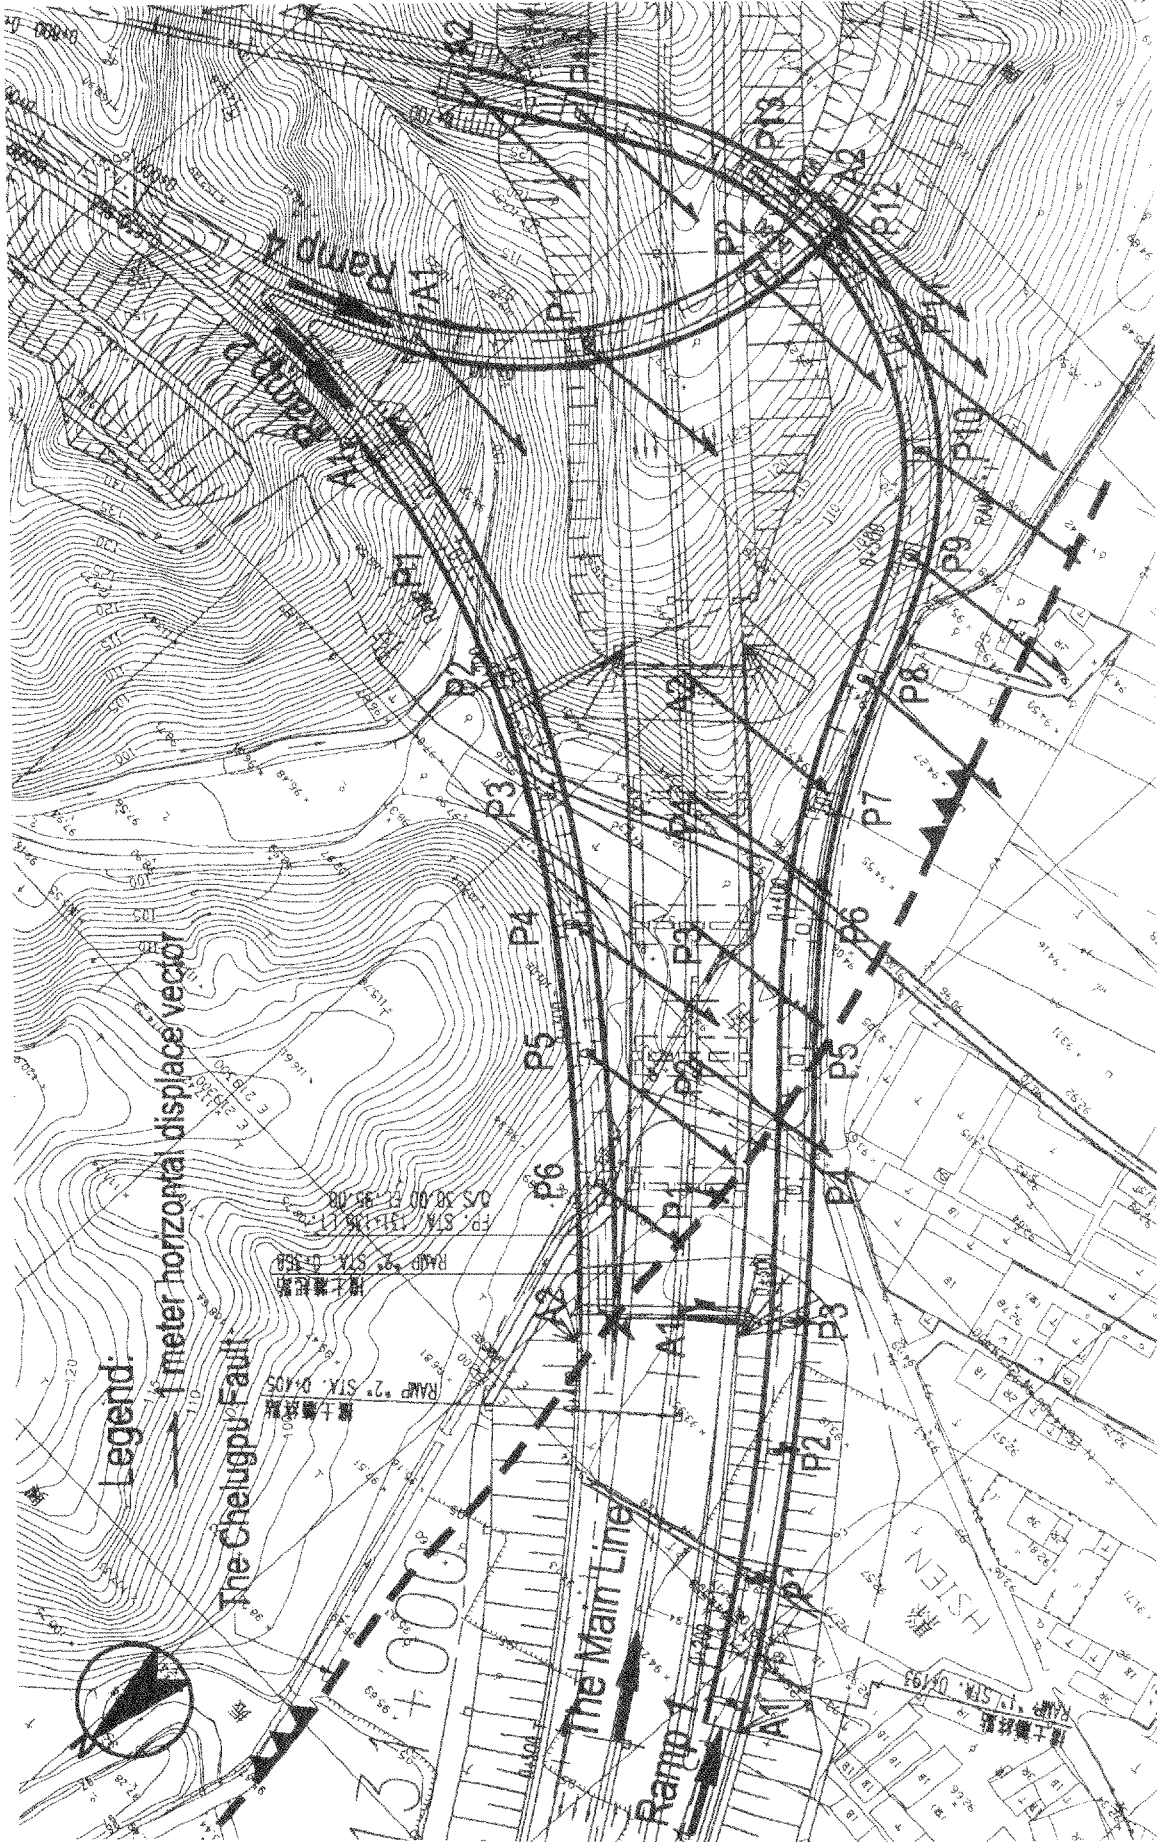
Figure 1 Layout of the 4 Routes and the Horizontal Displacement Vectors at the Piers

After the earthquake, damages to the abutments and piers can be observed. For example, the Pier P5 of Ramp1 was seriously tilted by the movement of the fault. The tilting is as large as 1/11. The abutments of Main line A1 and Ramp2 A2 collided and produced many severe cracks. The ground was also displaced and uplifted in the hanging wall. From the survey of the piers after the earthquake, the horizontal displacement at Ramp1 P11 is as large as 2.71m, and the uplift displacement at Main line P4 is as high as 1.64m. The averaged horizontal displacement vectors of the pier are plotted in Figure 1.

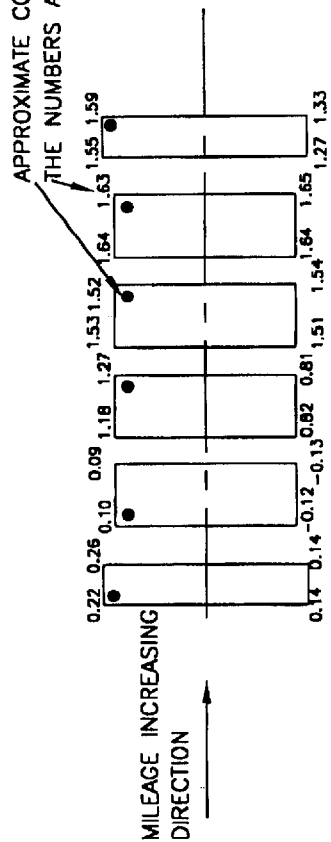
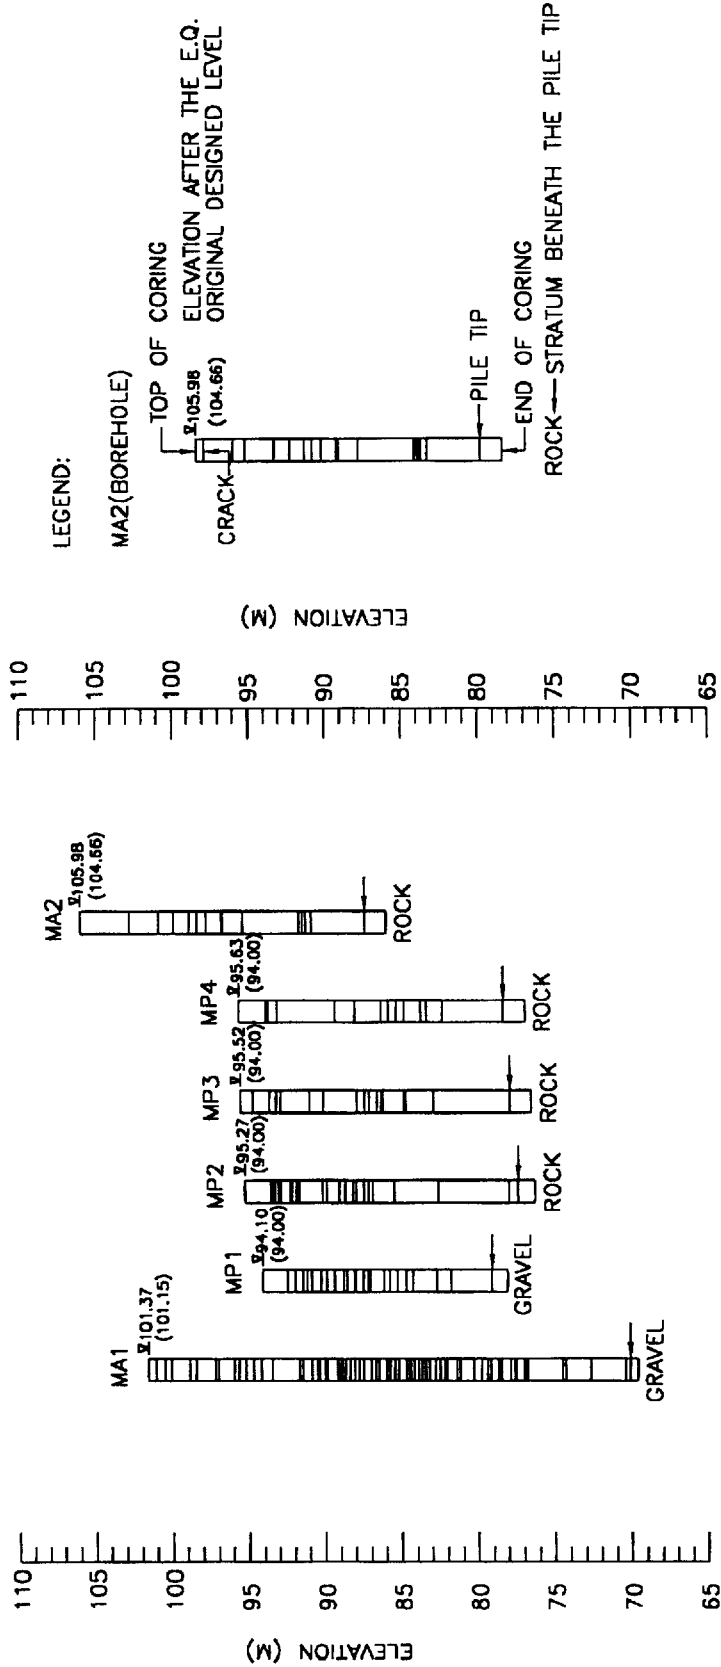
Figure 2 Crack Distribution of the Cored Piles for Main Line

Figure 2 displays that the piles of the Main line were significantly fractured because the fault passes through Main line A1 and P1. Moreover, the caps of the Main line were uplifted and tilted. The cap of MP2 was uplifted 1m in average and had a 0.46m difference in level. When coring at MP2 right passed its pile tip, the advancing rate suddenly increased, the water circulation reduced and recovery of the sample was zero. An aluminous rod was used to explore the gapping phenomenon. Conclusively, a 0.8m gap was inferred at the MP2 pile.

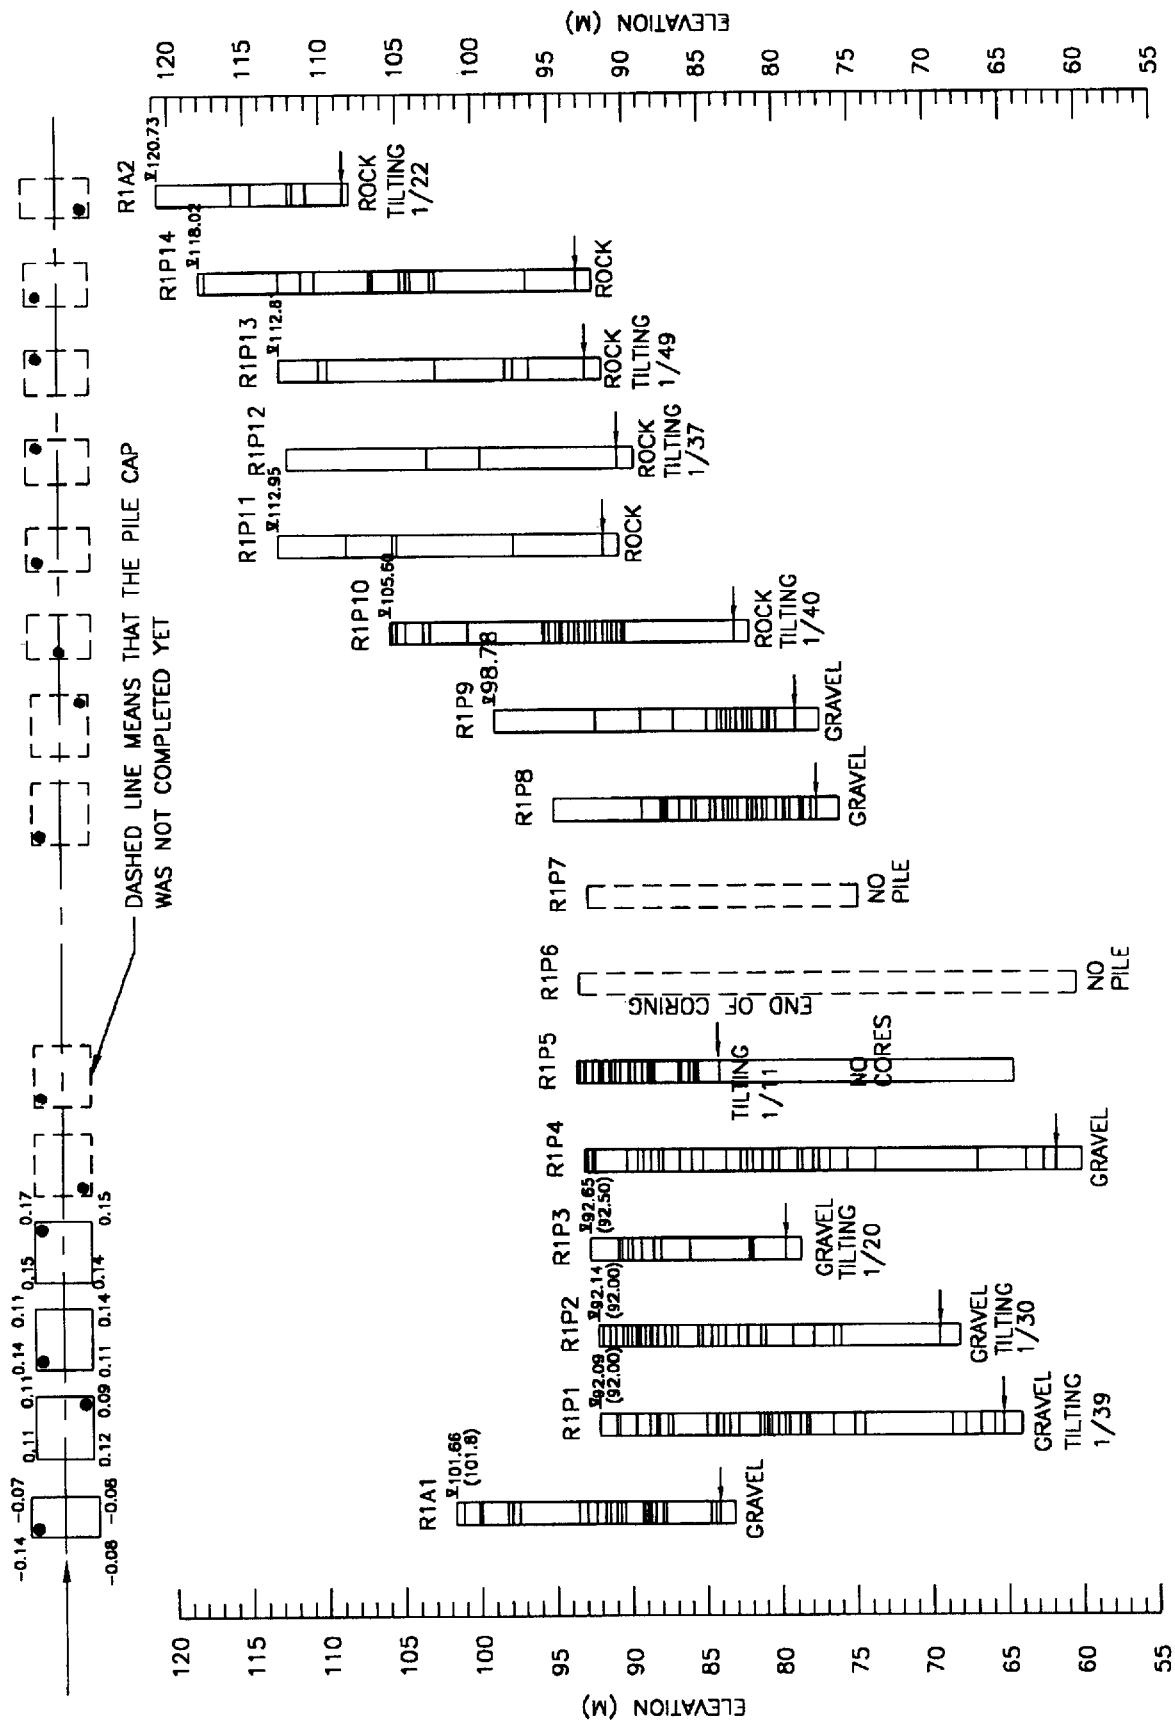
Figure 3 Crack Distribution of the Cored Piles for Ramp 1

Figure 3 shows that the crack situation in the piles of Ramp1 is severe. The fault passes through Ramp1 P5 and made it tilted. On both sides of the fault, the piles were seriously fractured. Those piles in the footwall (A1 to P5) have more cracks than those piles in the hanging wall. The possible reason is that the ground of the footwall is softer than that of the hanging wall so the pile-ground interaction was stronger in the footwall. In addition, the restraining of the caps of Ramp1 A1 to Ramp1 P3 may make more cracks near the pile heads. In addition to the cracks, gaps of at least 0.6m beneath the pile tips of R1P10, R1P14, and R1A2 were also encountered.

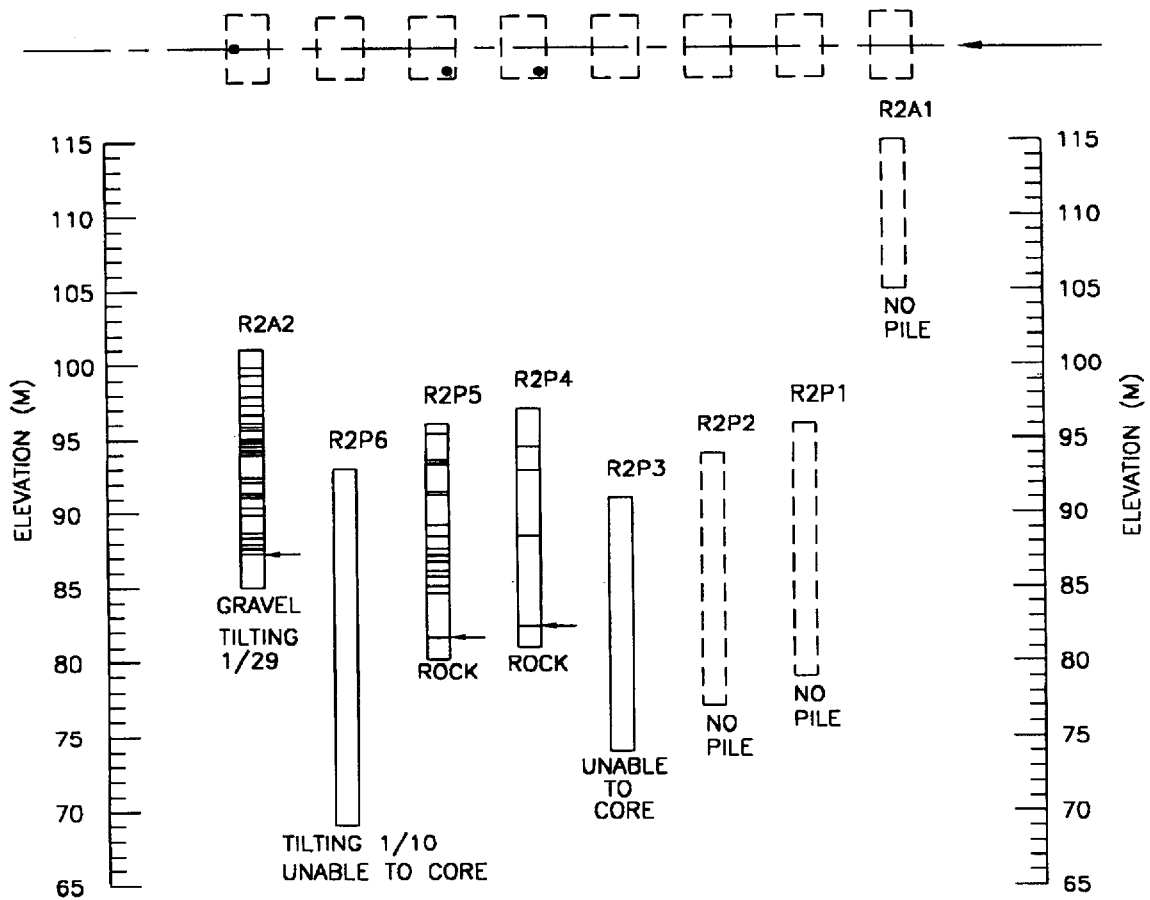
**Figure 4 Crack Distribution of the Cored Piles for Ramp2**

The fault also passes through Ramp2 A2 abutment. The cracking of R2A2 is serious. Bare eyes can easily observe tilting of R2P6. The crack distribution of Ramp2 can be seen in Figure 4. Cracks appeared to be less in the piles of Ramp4 (Figure 5) whose distance to the fault is greater than those of the other 3 routes. However, R4P1 was tilted and R4P2 has many cracks too. Moreover, a gap of 1.6m was detected beneath the pile tip of R4A2.
