An Evaluation of the Erosion Control Method with Drainage, Staking and Wattling in Taiwan after Typhoon Mindulle

An Evaluation of the Erosion Control Method with Slope Drainage, Staking and Wattling in Taiwan after Typhoon Mindulle

ABSTRACT

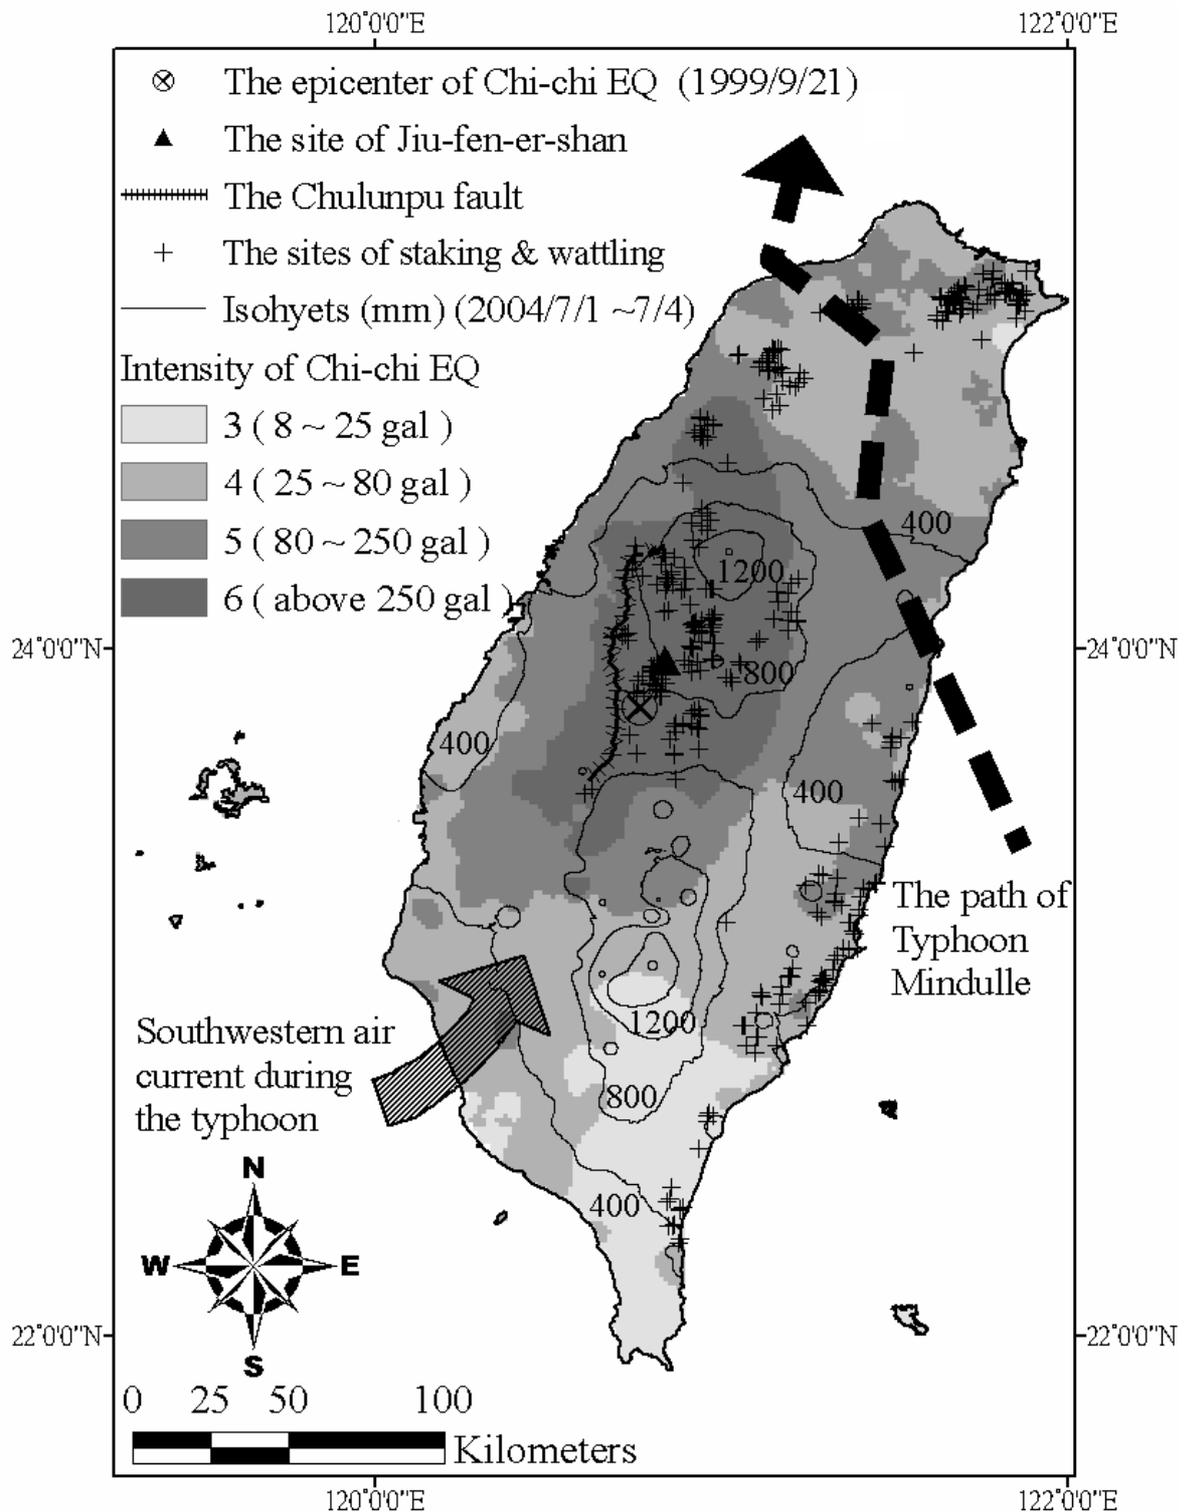
圖1 沖蝕控制處理工址及九份二山位置套疊敏督利颱風等雨量線與集集地震強度等勢能線
 Figure 1 Sites adopting erosion control method and Jiu-fen-er-shan with Typhoon Mindulle isohyets and Chi-chi earthquake intensity contours.

Figure 1 shows that the path of Typhoon Mindulle and the isohyets of the induced rainfalls. The site of Jiu-fen-er-shan is shown with a solid triangle. In the Figure, the intensity contours of 1999 Chi-chi earthquake, epicenter, the Chulunpu fault, and where the sites treated with the erosion control method are all shown. It can be observed that in central Taiwan it is “ravaged” by the earthquake and typhoons.

This study continues to collect sites where damages occurred after typhoons. Additional comparisons can be made for geological condition and soil types when the amount of the sites is enough. The coordinates of damage sites can be further overlapped in Geographical Information System with geological and soil layers, similar to Figure 1, to compare their relationships.

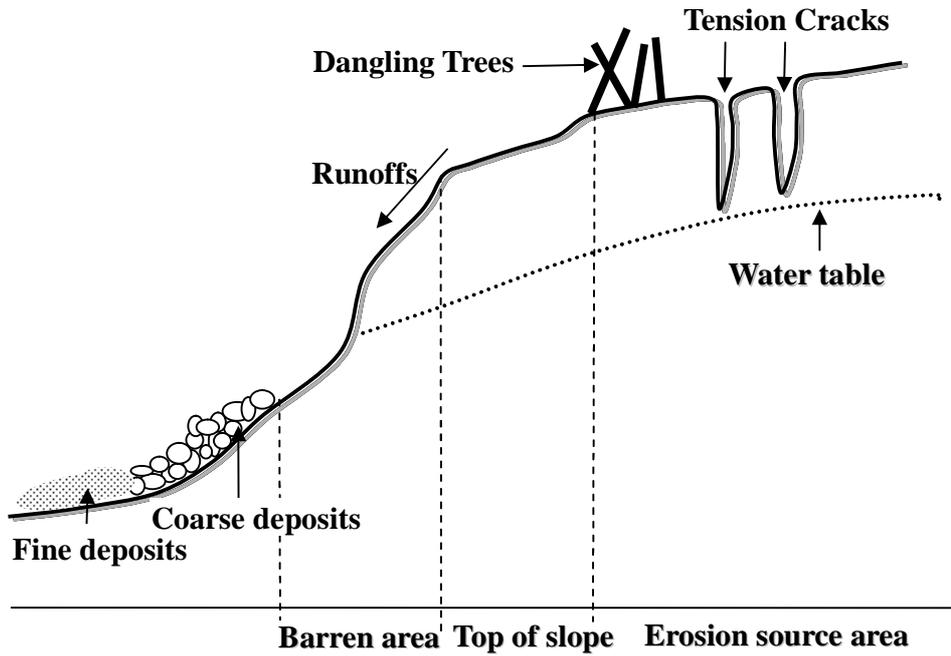
圖 2 崩場地與不穩定邊坡問題示意圖

Figure 2 Problems of a landslide and unstable slope.

Normally a landslide and unstable slope have some cracks on top of the slopes. There may be tree dangling on slope face. Runoffs cause sheet/gully/rill/inter-rill erosion; and there are deposits near toe of slopes as shown in Figure 2. The method includes three major strategies of treatment, as following and is shown in Figure 3 & 4.

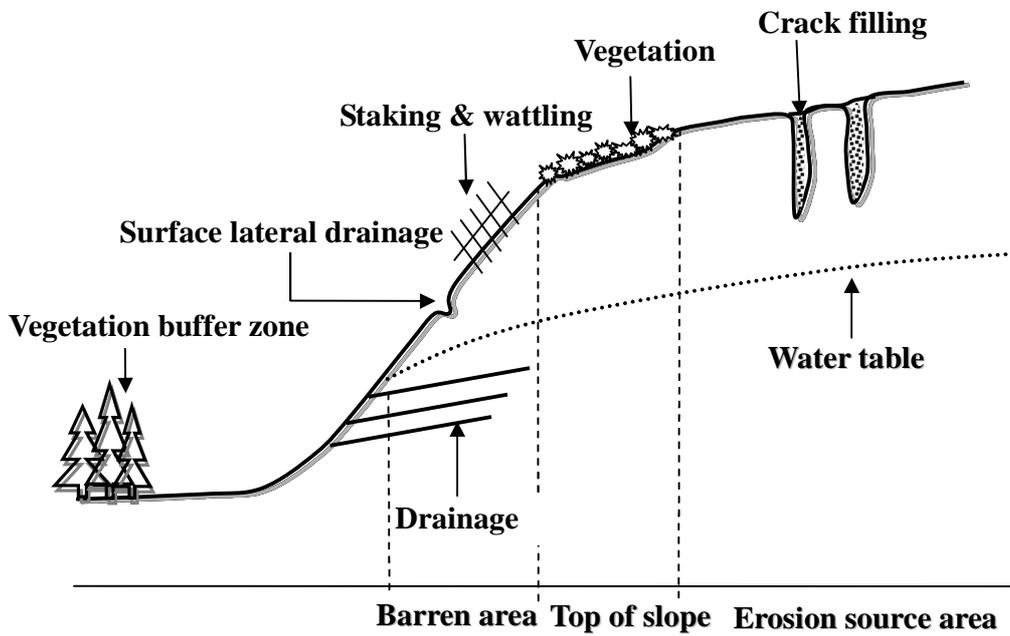
圖 3 邊坡沖蝕控制處理示意圖

Figure 3 Treatment of the erosion control method.

- Erosion source treatment on top of slope: backfill cracks, build lateral drain ditches, clean dangling trees, etc.
- Slope surface treatment: construct lateral and longitudinal drain ditches, perform staking and wattling (Figure 5), vegetate, etc.
- Treatment at toe and deposits: build toe ditches, construct soil nails, construct gabions, drill drainage pipes in slope toe, replant buffer zone, etc.

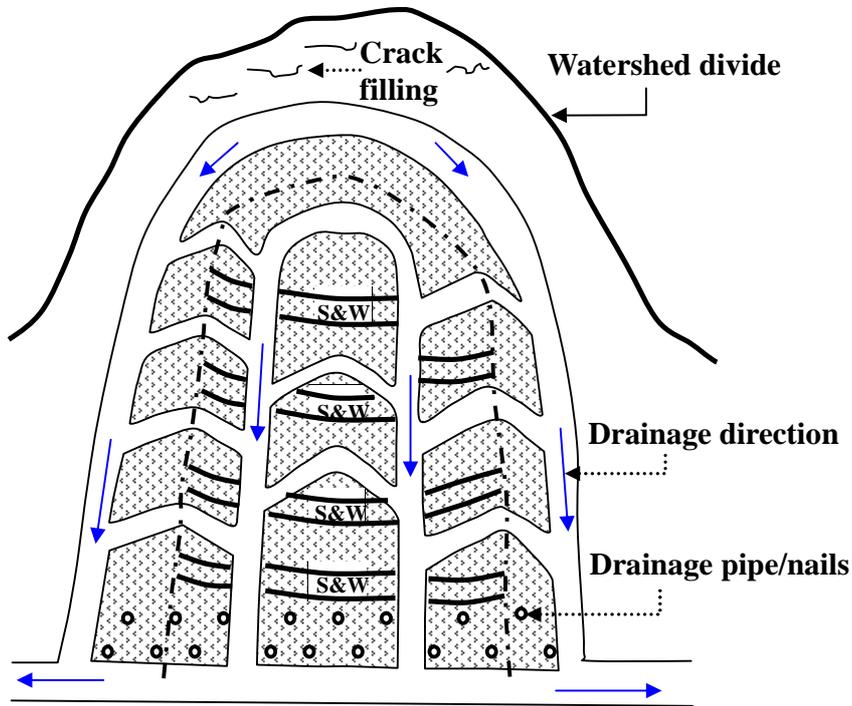
圖 4 邊坡沖蝕控制處理正視圖

Figure 4 Front face of the slope treated with the erosion control method

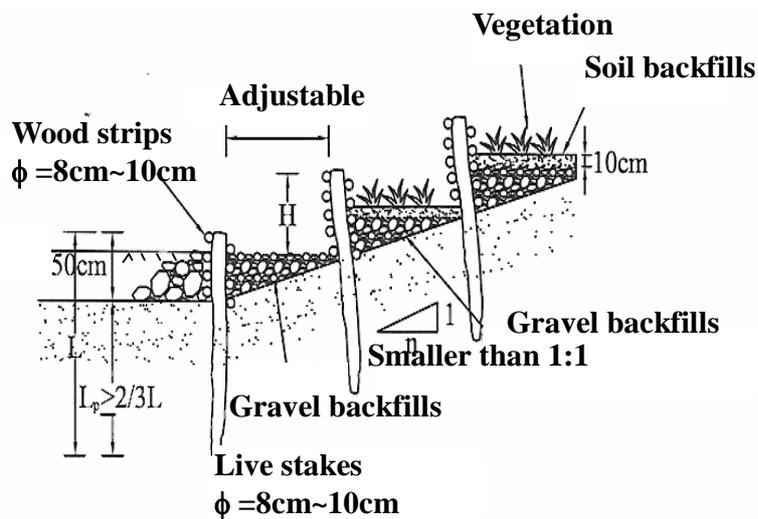
圖 5 坡面打樁編柵示意圖 (2)

Figure 5 Staking and wattling on slope surface (2)

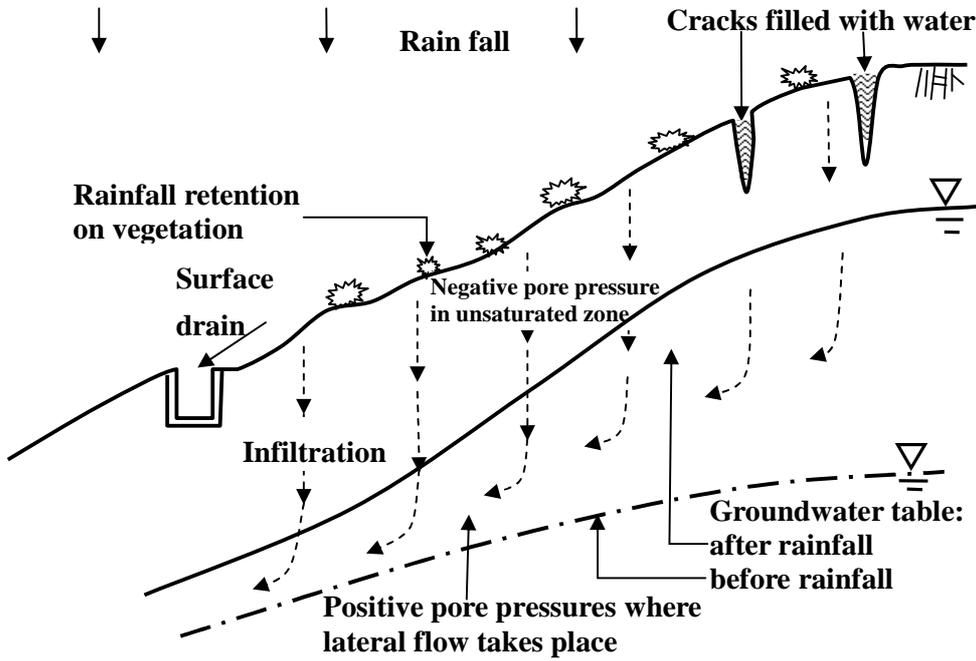
圖 6a 邊坡未填補裂縫降雨入滲情形與可能地下水位示意圖

Figure 6a Infiltration on slope and possible groundwater table after rainfall – before filling cracks

If tension cracks on a slope are not treated and are filled by rainfall water, the groundwater table would be raised higher (Figure 6a). This will cause the slope materials to soften, reducing shear resistant strength (resistance) and increasing self-weight (driving force) of the slope. The safety factor of the slope will be greatly reduced. However, if the cracks are treated with fillings that prevent water from entering the slope (Figure 6b), the groundwater table would only be raised by infiltration and remains at a much lower level. The slope could have a relatively better stability.

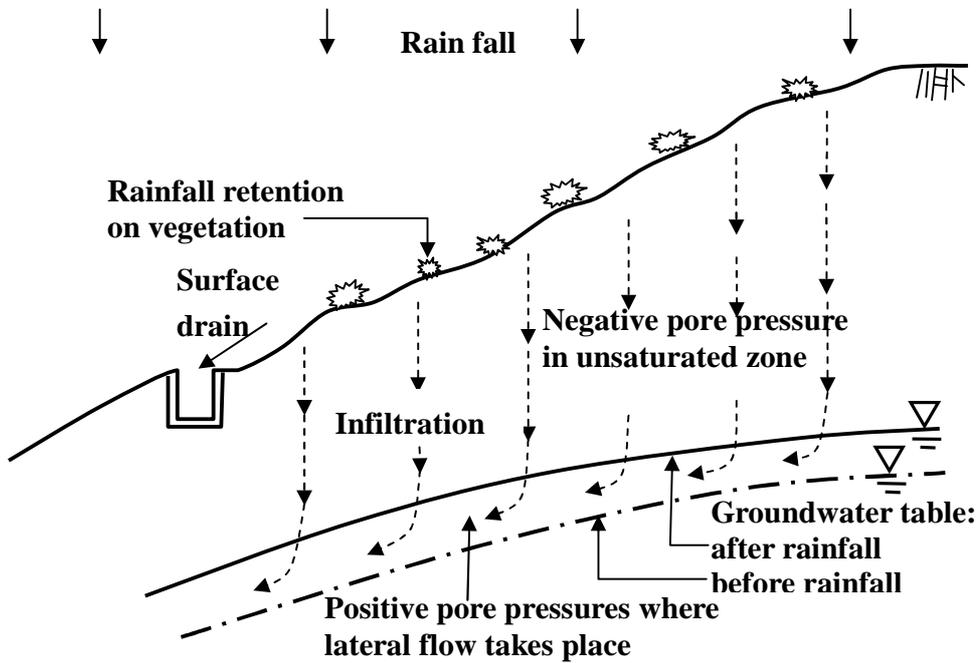
圖 6b 邊坡填補裂縫後降雨入滲情形與可能地下水位示意圖

Figure 6b Infiltration on slope and possible groundwater table after rainfall – after filled cracks

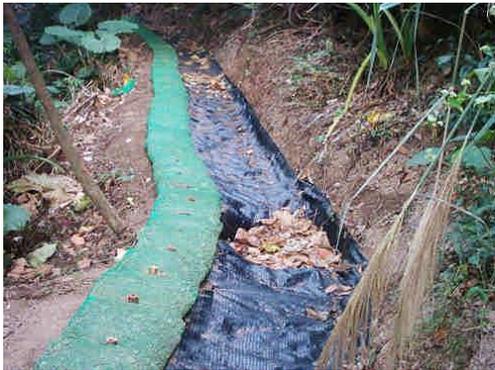
圖 7a 邊坡坡頂回填透水材料截水 (5)
Figure 7a Water cutoff at top of slope by backfilling (5)

The basic principle for drainage is to prevent water from entering the landslide slope. Various drainage facilities can be used to fulfill the needs, such as longitudinal and lateral drainage ditch, waterfall, drainage pipe, etc. More environmental friendly treatments such as grass ditch, stone ditch, backfill-bag ditch, etc. Figures 7a~7d show some of the practical application of installing a drainage system for a slope on top, on the surface and at the toe. The design of the ditch is mostly based on “rule of thumb”. However, detail calculations for the ditches can be completed using Manning’s equation when necessary. Note that lateral drainage should be less than 2 degrees in order not to damage the slope again. Pools of water should be avoided to reduce failure possibility of drainage works. The length of longitudinal drainage should be increased as long as possible to reduce sloping and energy dissipation works such as waterfall should be added. It may be necessary to meander the longitudinal drainage work. Large drainage works may be required beneath the cliff and upper zone of an alluvium.

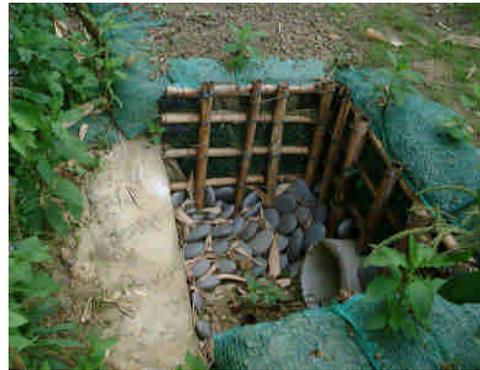
圖 7b 採用自然資材設計之疊水工 (5)
Figure 7b Waterfall using natural materials (5)

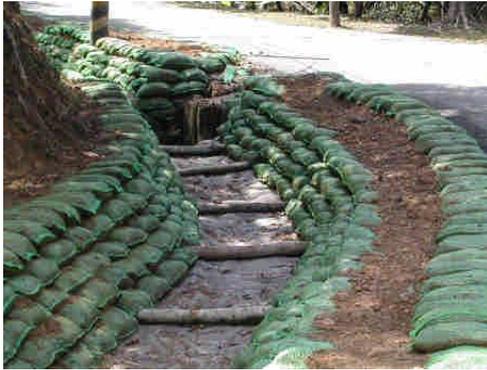
圖 7c 坡趾掘溝排水 (5)
Figure 7c Ditch at toe (5)

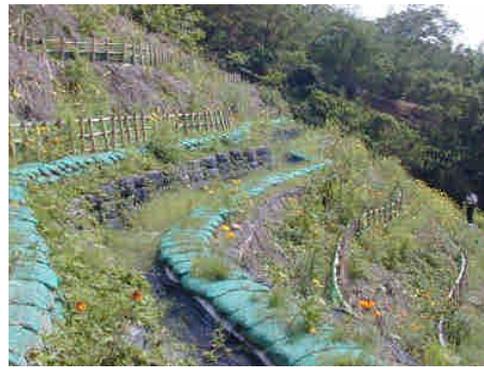
圖 7d 坡面背填土袋橫向排水與植生 (5)
Figure 7d Backfill-bags for lateral drainage and vegetation on slope surface (5)

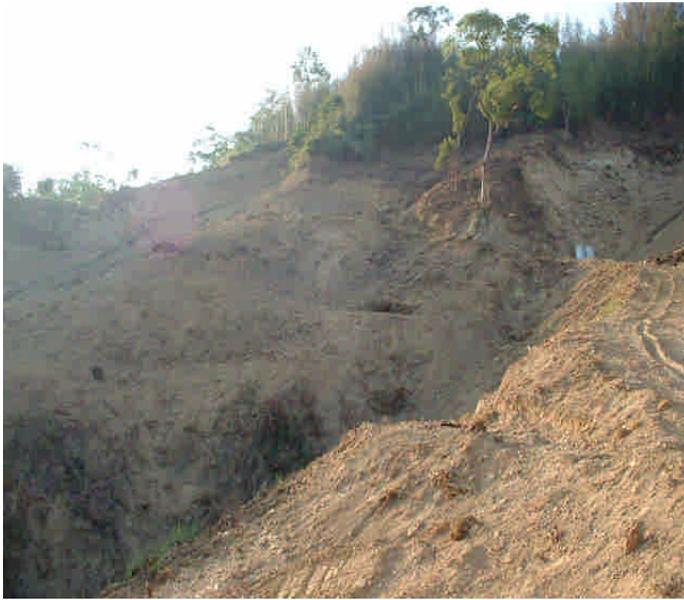
圖 8a 崩場地處理現址-施工前(三灣鄉)

Figure 8a A landslide site before construction
(Sanwan Xiang, Taiwan)

Properly designed erosion control method can be effective in stabilization a landslide area and restoration of a local ecosystem. During planning and design stages of mitigations, factors such as safety, ecology, landscape, geomorphology, and hydrology should be comprehensively considered. It is often found that after a landslide area is stabilized, the ecosystems reinstate gradually after using the erosion control method(2). A successful example site in Sanwan Xiang, Taiwan, adopting the erosion control method is shown in Figure 8a~8c for before, during and after the construction. The landscape scene after re-vegetation is satisfied. Figure 9 shows a comparison between with and without the erosion control method at a same site. It is obvious that the part with the treatment is stable and re-vegetates very well without further erosion.

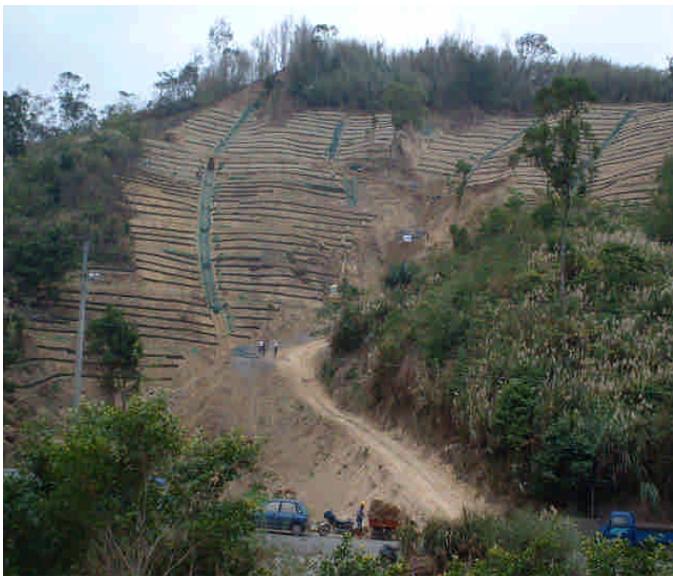
圖 8b 崩場地處理現址-施工中(三灣鄉)

Figure 8b During construction

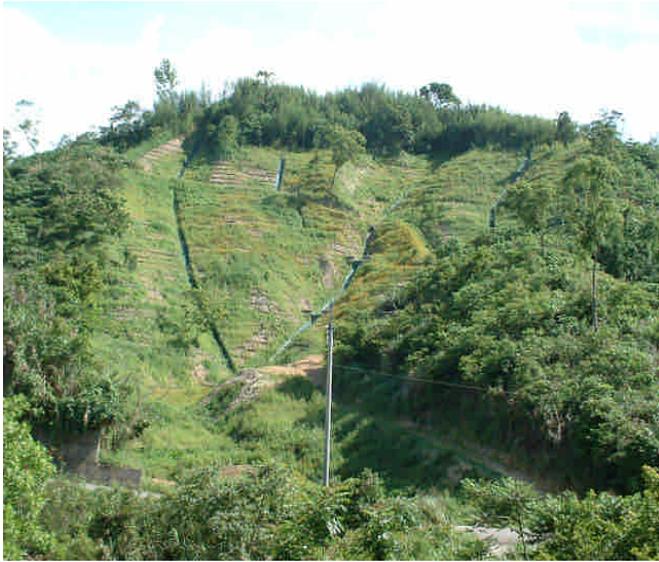
圖 8c 崩塌地處理現址-施工後(三灣鄉)

Figure 8c After construction

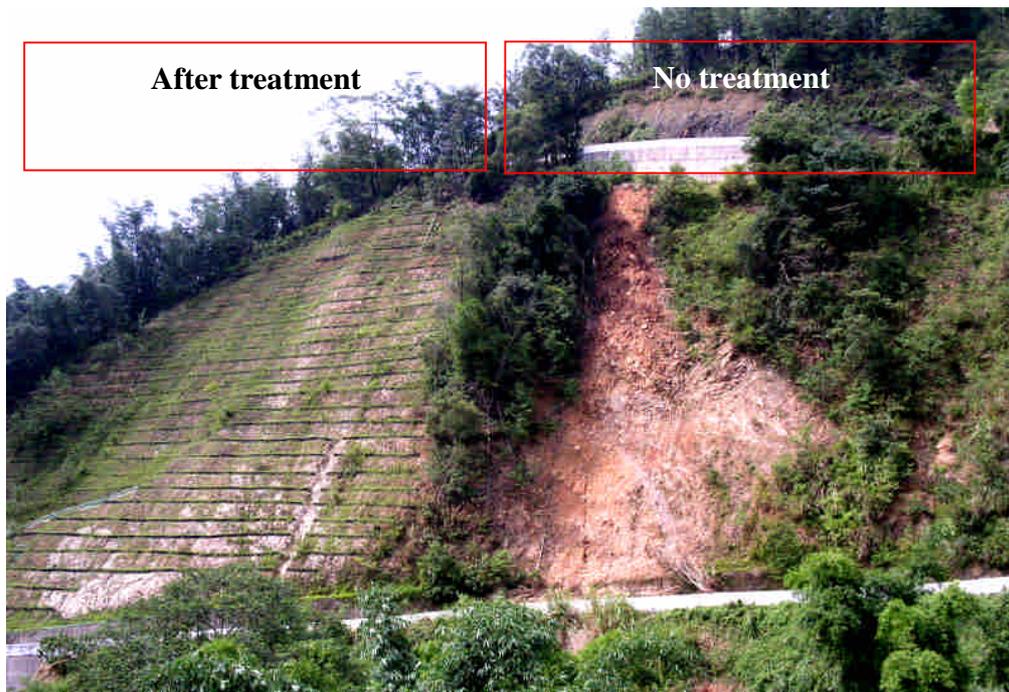
圖 9 邊坡進行沖蝕控制處理與未處理影響比較 (2)

Figure 9 A Comparison of the Effect of the Erosion Control Method (2)
